Quinquennial Report

Elgol Church

Church of Scotland Lochcarron and Skye Presbytery
October 2016

PROPERTY ELGOL CHURCH

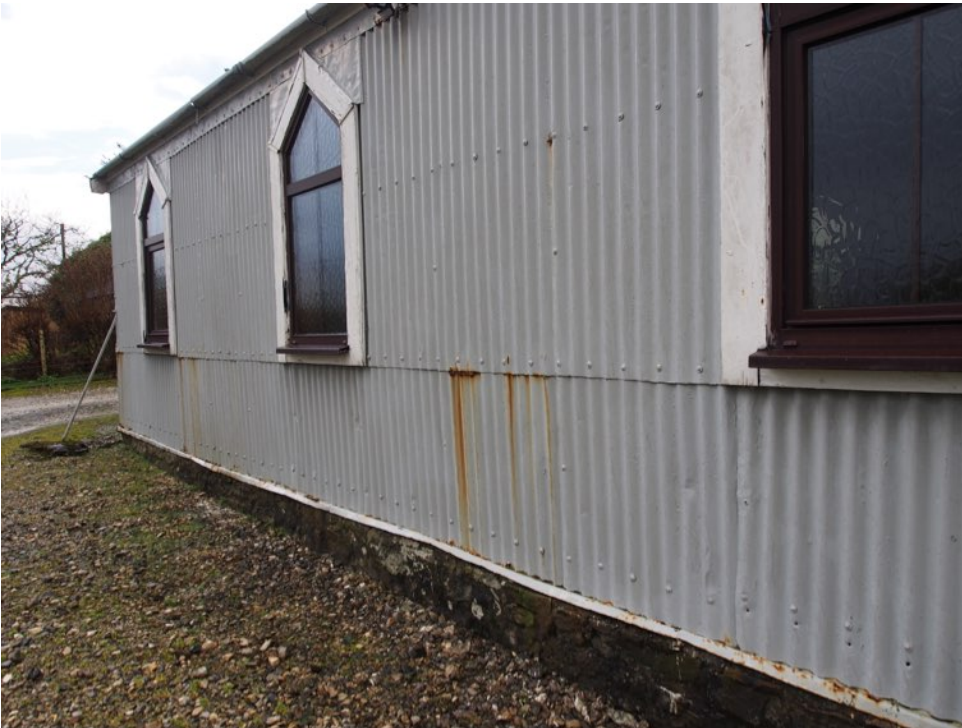
Bow in front elevation

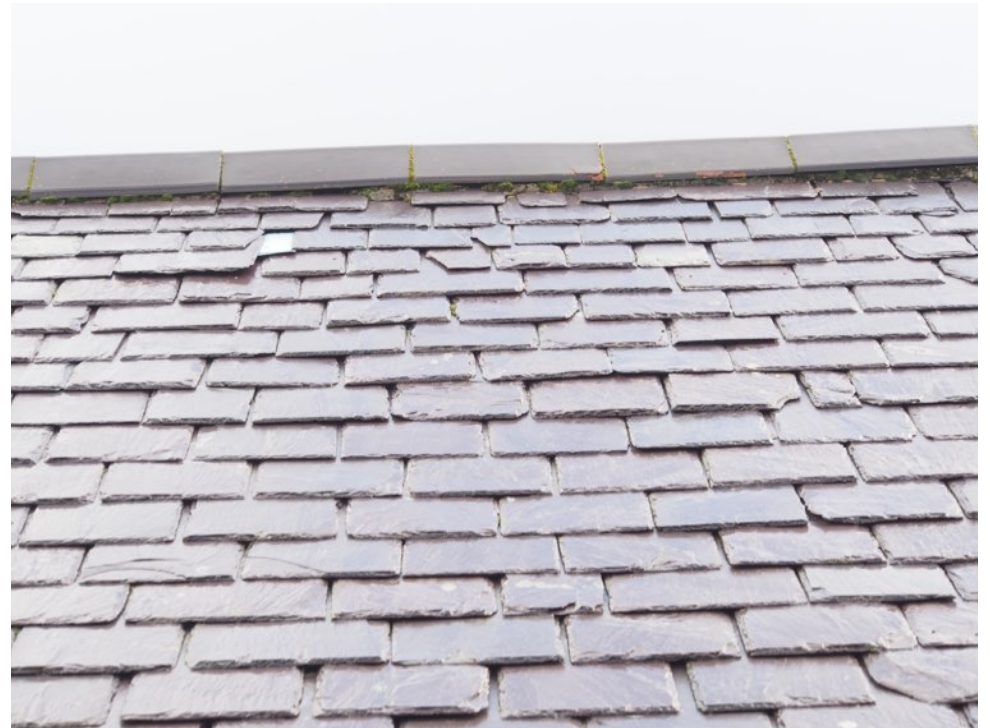
Slating showing gaps and cracked slates

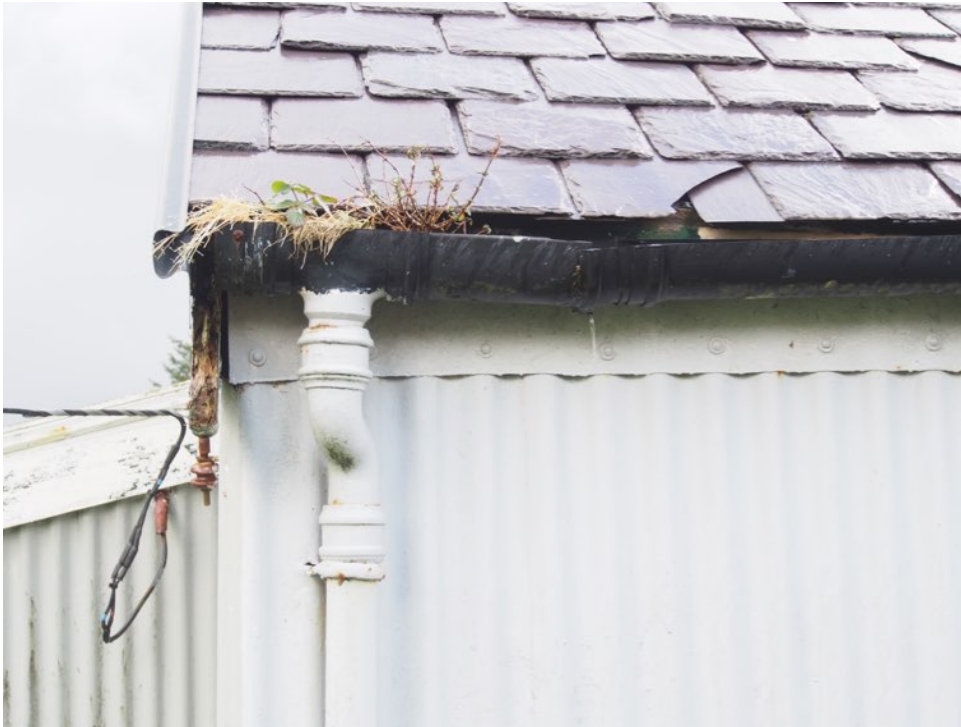
ELEMENT	DESCRIPTION	CONDITION	RECOMMENDED REPAIRS	PRIORITY	COST
Rainwater goods	UPVC gutters Cast iron downpipes. Store extension has UPVC downpipe	On the front elevation there are replacement sections of gutter which are not properly bedded and sealed, consequently there are a number of drips. At the rear elevation the gutter is defective adjacent to the downpipes, and also blocked with vegetation. There are drips at the gutter to the extension. All downpipes discharge to ground.	Re-bed and seal gutters to store rear and porch. Replace gutter to front elevation. Drainage to be taken to soakaway.	U	800
Spire, bellcote, finials	-				
WALLS	Corrugated iron sheeting on timber frame. Stonework sub-structure at base.				
Wall structure	Timber frame	There is a slight bulge in the front and rear walls. The flashing detail at the base of the wall cladding is severely corroded in places and may well have caused damp to affect the floor joists which have sunk, in turn causing the bow in the side walls. This may account for the dip in the floor internally. The roof may not have been originally slated, and if the slates have been added, this may have increased outward pressure on the walls too.	Open up to investigate condition at base of wall and on internal wall lining	U	800 (opening up and investigation only)

Rear gutter blocked and leaking

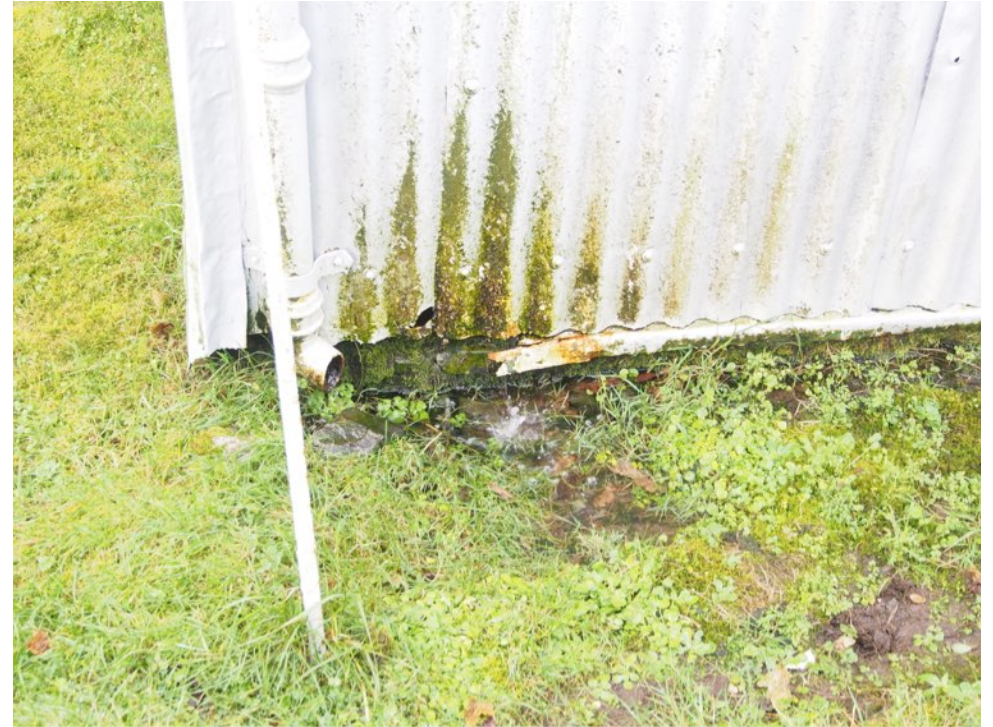
Rear downpipe with corrosion around base of wall lining

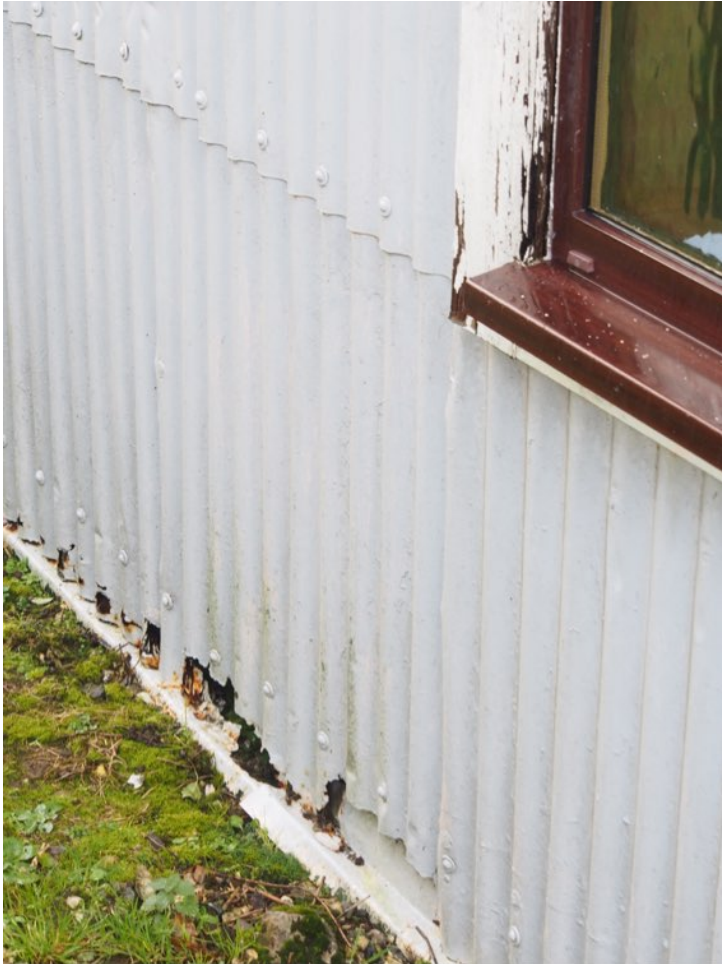
Corroded flashing at base of rear wall

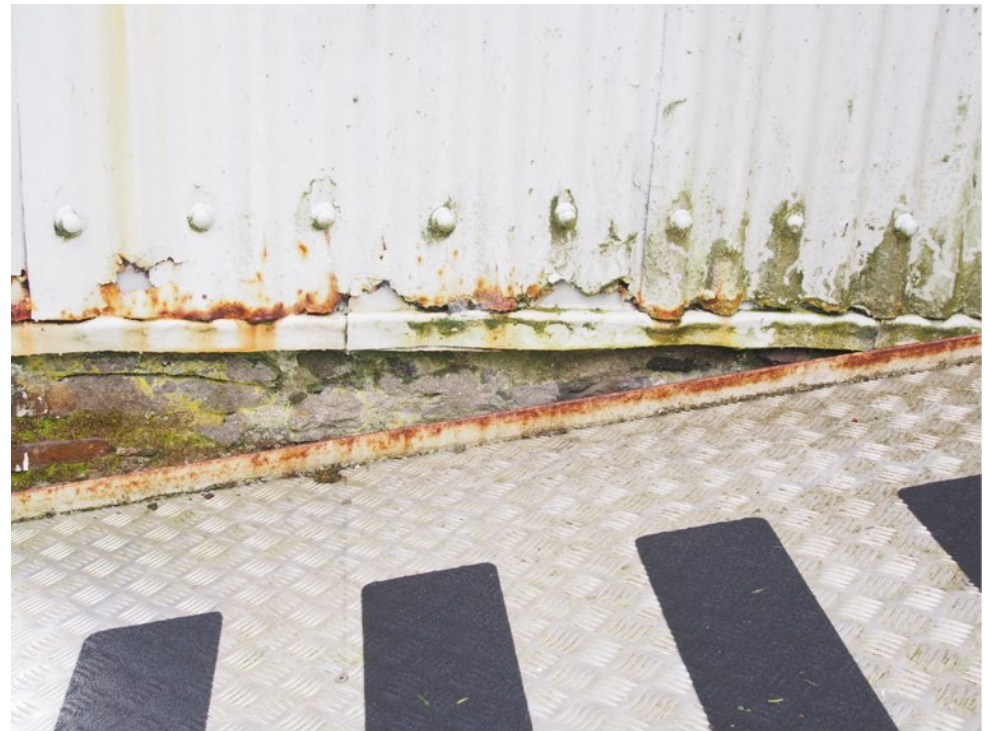
Corroded flashing at base of North East gable wall

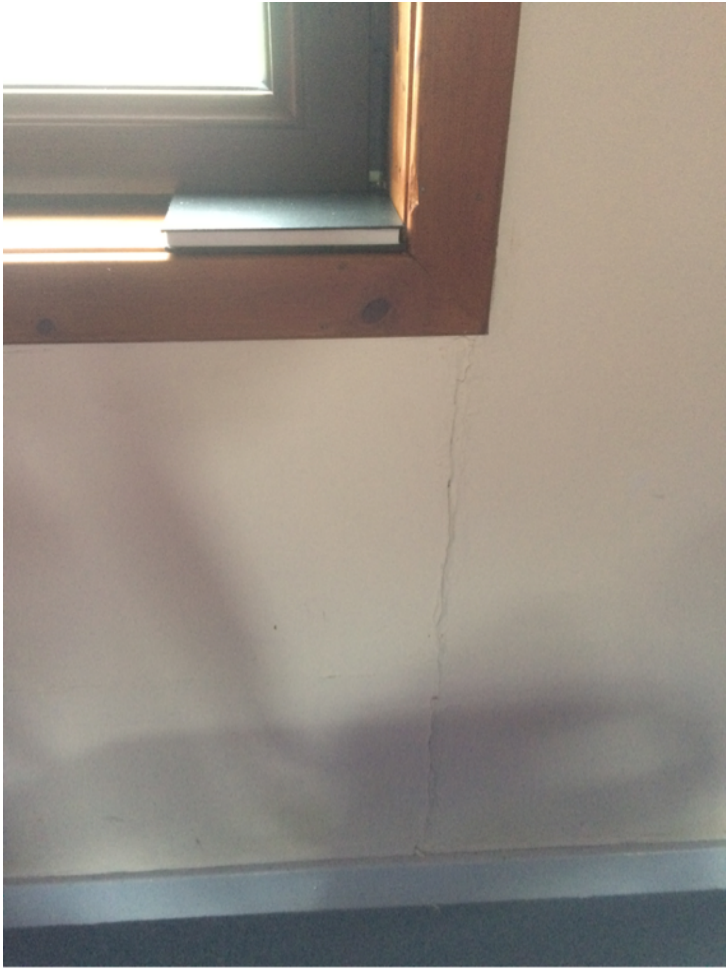
Crack on internal wall South East elevation

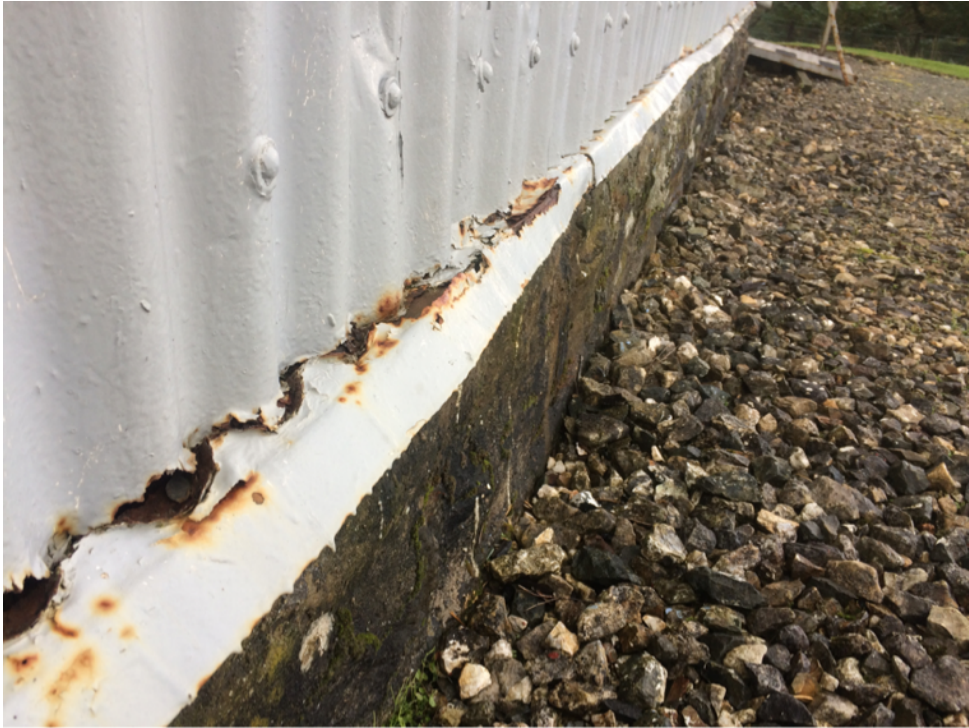
Defective flashing at base of front wall

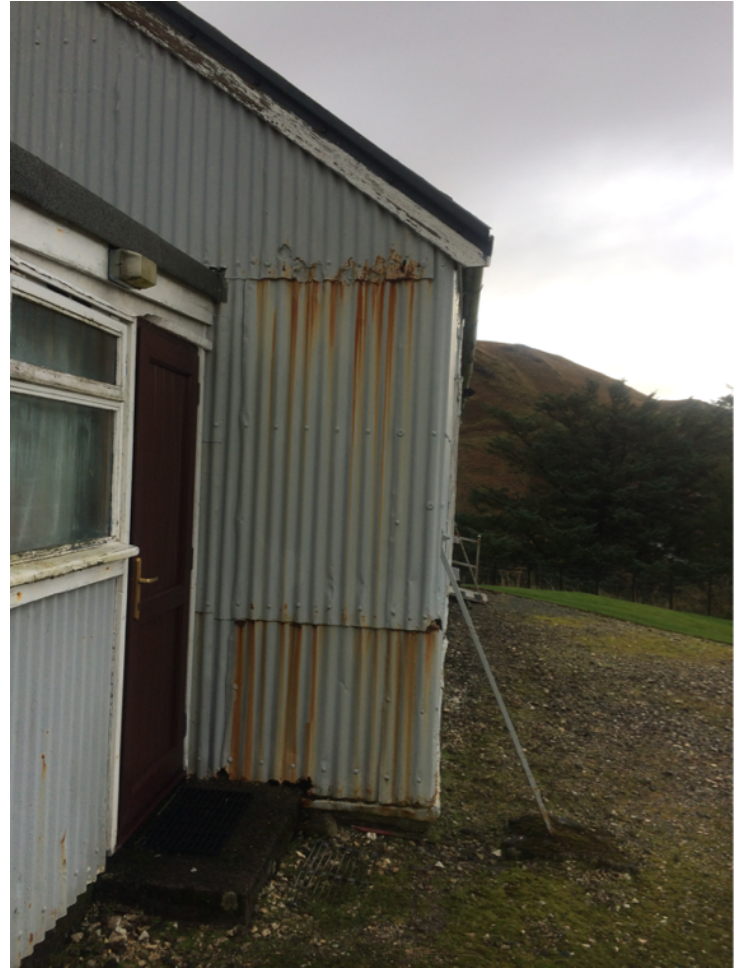
ELEMENT	DESCRIPTION	CONDITION	RECOMMENDED REPAIRS	PRIORITY	COST
Wall finish	Corrugated iron sheeting Stonework base course	A number of areas of corrugated iron are in poor condition, particularly where sheets have been formed around corners, the bottom of sheets at the base flashing and adjacent to rear downpipe. Paint finish in poor condition. Stonework pointing in poor condition	Replace corroded sheets, replace base flashing. Re-point stonework	U	5500
Metalwork etc	-				
CHIMNEYS AND FLUES	-				
EXTERNAL WOODWORK	Timber barge boards Timber facing to window surrounds	Poor condition with rotten end sections to barge boards and decay in window surrounds	Replace	E	1600
DOORS AND WINDOWS	UPVC windows, double glazed UPVC door to store extension Timber window to store Timber main door	UPVC door and windows and in reasonable condition. Timber door and window in poor condition	Replace timber entrance door and store window.	D	1600

Rust and corrosion in corrugated iron sheets
