Quinquennial Report

Broadford Church Hall

Church of Scotland Lochcarron and Skye Presbytery
October 2016

PROPERTY BROADFORD CHURCH HALL

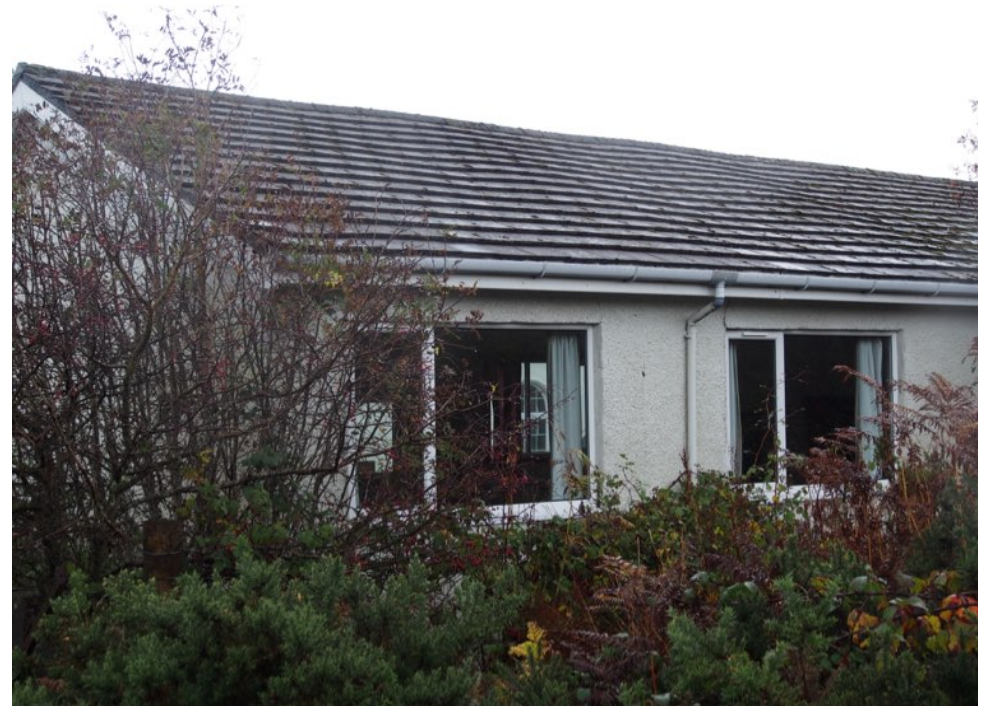
Partial south elevation showing uneven ridge

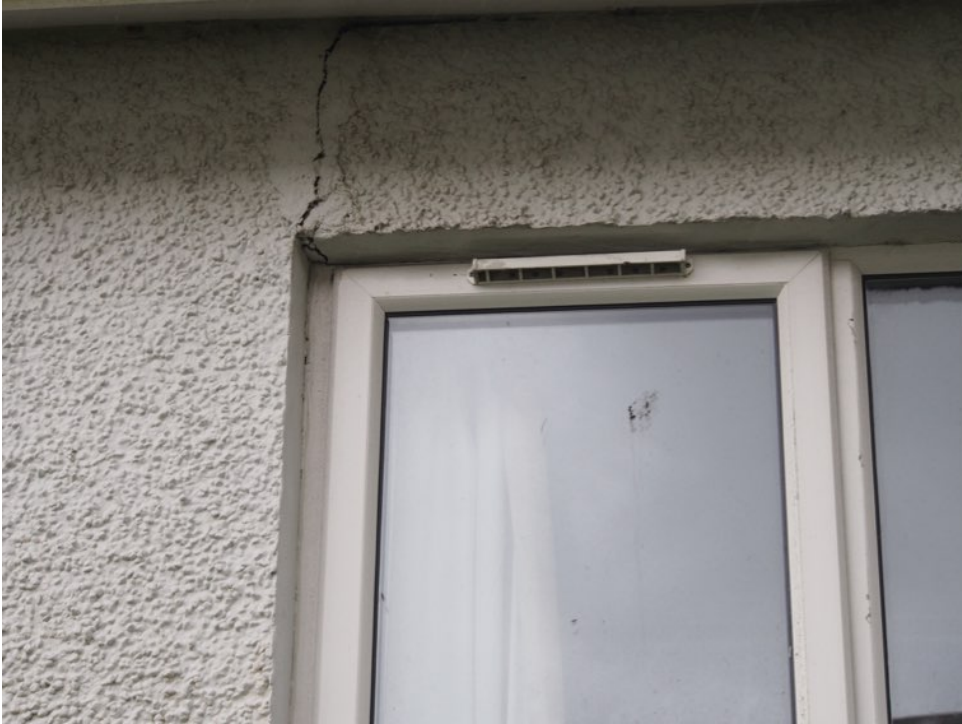
The building is currently closed for public use as it is considered unsafe and unsuitable. The structural cracks above the windows affect a considerable proportion of the wall structure, and taken together with the severe water ingress at the roof, mean that the building cannot be occupied. The structural issues require comment from an engineer if the building is to be renovated, and for this reason we have not included any costs in the report as there is insufficient information at this stage.

Typical crack above window, north elevation

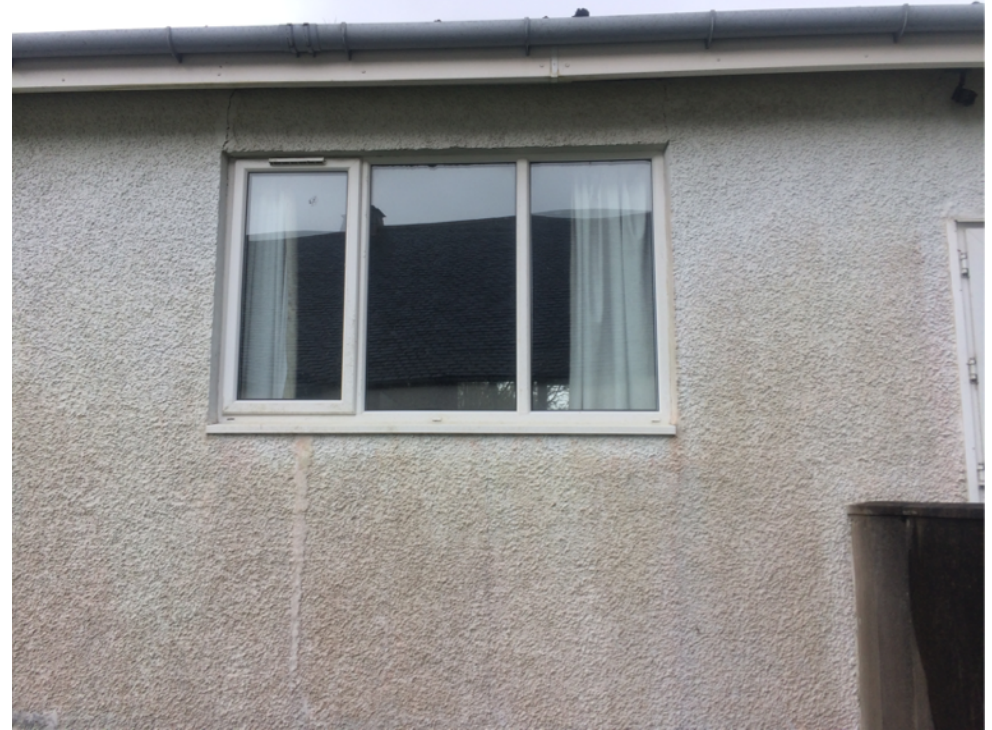
Partial north elevation showing cracks

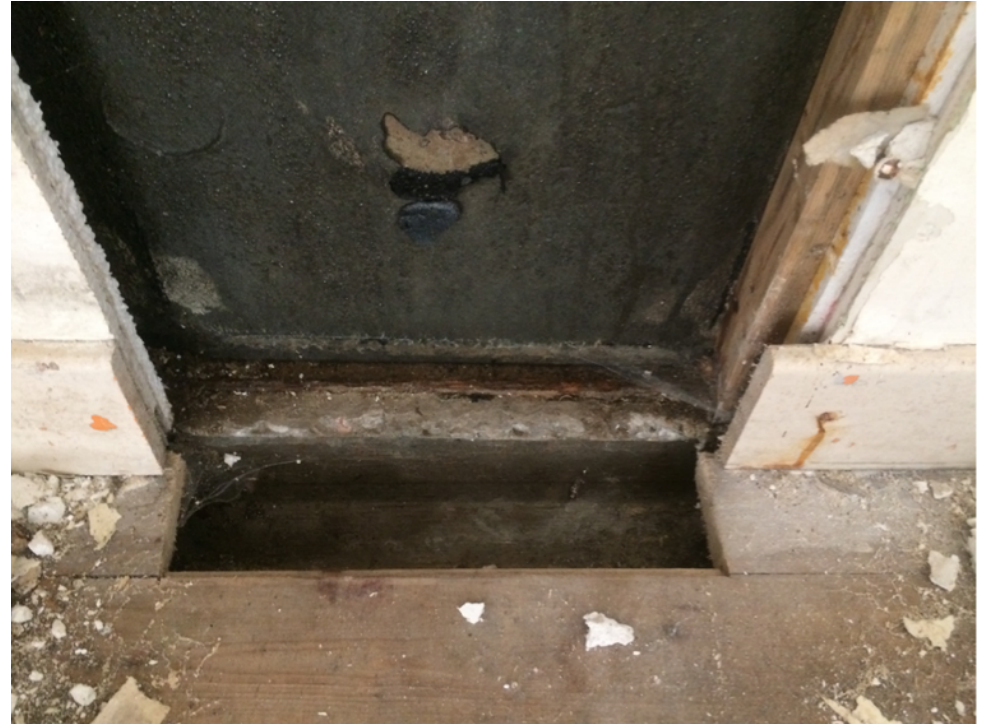
Typical panel construction at south wall

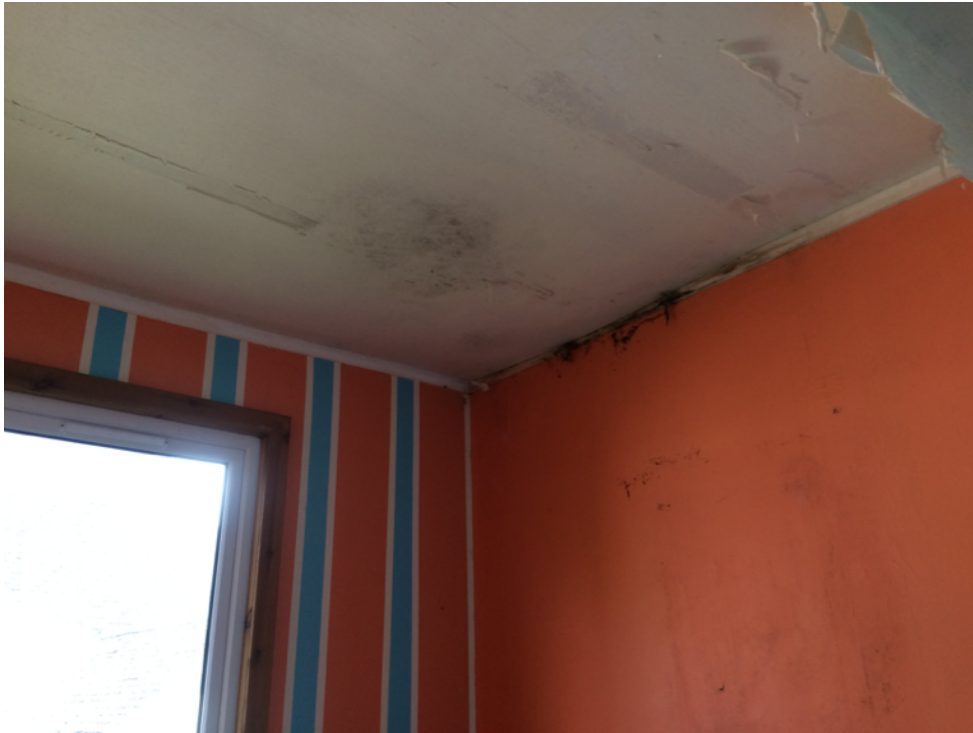
Damaged ceiling and wall in end room

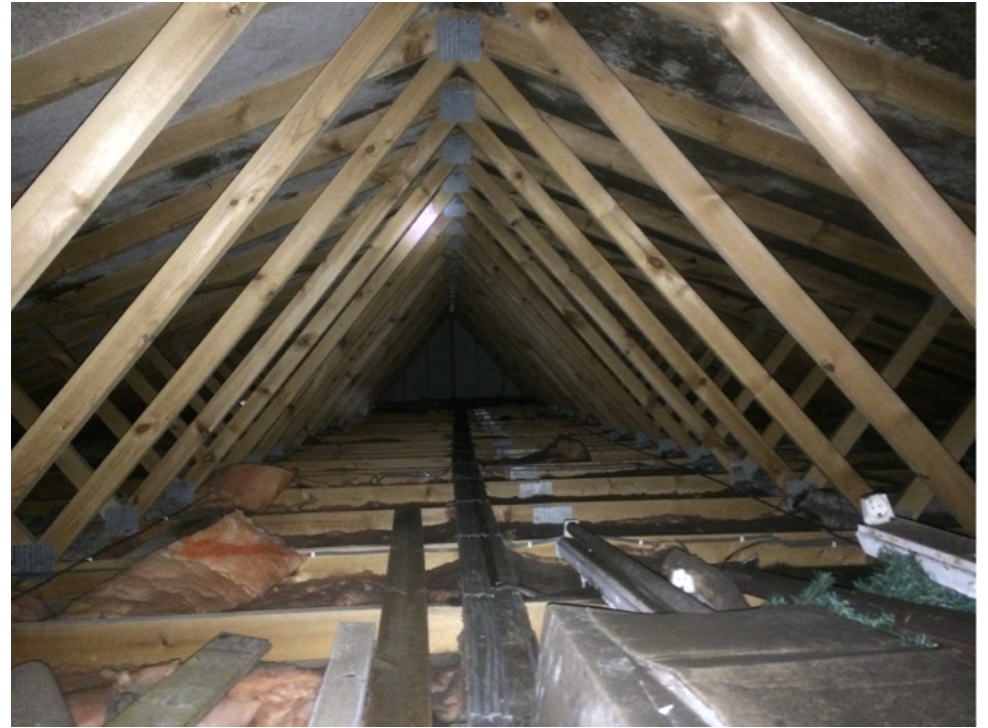
Roof space showing all sarking damp
