Quinquennial Report

**Kilmore Manse**

Church of Scotland Lochcarron and Skye Presbytery  
November 2016

## PROPERTY KILMORE MANSE

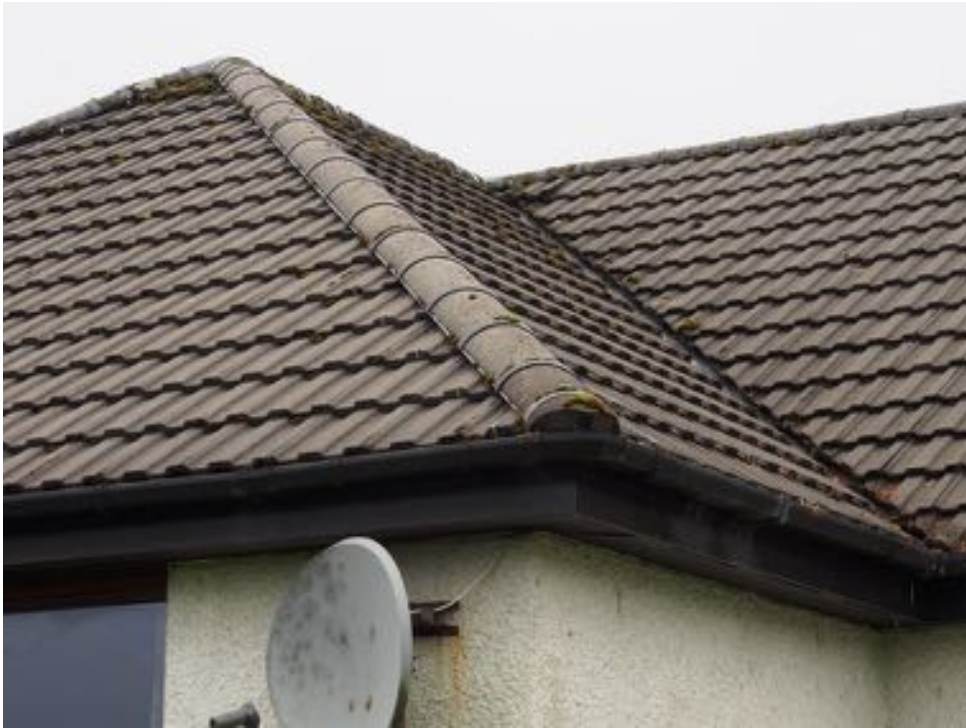
ELEMENT	DESCRIPTION	CONDITION	RECOMMENDED REPAIRS	PRIORITY	COST
<b><u>EXTERNAL</u></b>					
<b>ROOFS</b>	Pitched roof with hipped ends				
Roof Coverings	Profiled concrete roof tiles	Satisfactory. Ridge tiles showing some signs of wear			
Flashings	Lead flashing to valley	Satisfactory	Note bottom of valley tends to collect vegetation growth and should be regularly cleared		
Skews and parapets	-				
Rainwater goods	UPVC gutters and downpipes	Satisfactory			
Spire, bellcote, finials	-				
<b>WALLS</b>	Timber frame construction with blockwork outer leaf				
Wall structure	Structural timber frame	No apparent cracks in outer leaf of wall.			
Wall finish	Self coloured wet dash cement render	Satisfactory			
Metalwork etc	-				
<b>CHIMNEYS AND FLUES</b>	Metal flue to oil fire boiler	Satisfactory			
<b>EXTERNAL WOODWORK</b>	Redwood fascias and ply soffits	Satisfactory

Roof tiles on South East elevation

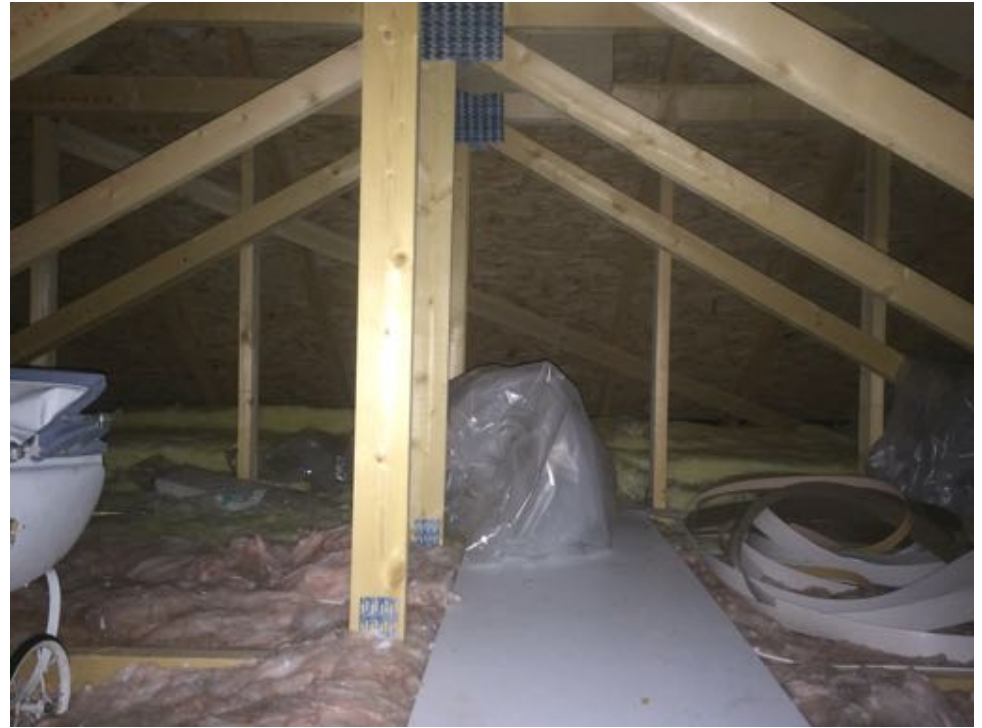
Roof space

ELEMENT	DESCRIPTION	CONDITION	RECOMMENDED REPAIRS	PRIORITY	COST
<b>DOORS AND WINDOWS</b>	Timber double glazed windows. Half glazed front door Glazed sliding patio door	Generally in reasonable condition Sliding patio door in moderate condition and would benefit from external redecoration			
EXTERNAL PAINTING	Soffits and fascias have timber stain finish	Reasonable condition	Re-paint patio doors	D	50
EXTERNAL DRAINAGE	Surface water drainage to soakaway Foul drainage to septic tank, not seen				
GARDEN AND GROUNDS	Gravel parking area, grass and shrubs to garden	Satisfactory			
FENCES, GATES, WALLS	Post and wire fence	Satisfactory			
<b><u>INTERNAL</u></b>					
<b>ROOF SPACE</b>	Roof structure comprises trusses at 600mm centres	Satisfactory			
Insulation	Double layer of glasswool insulation quilt over part of the loft space. The central section has 100mm quilt	Reasonable condition	It would be possible to tidy up the glasswool to avoid any gaps and consider increasing insulation depth over middle part	D	200

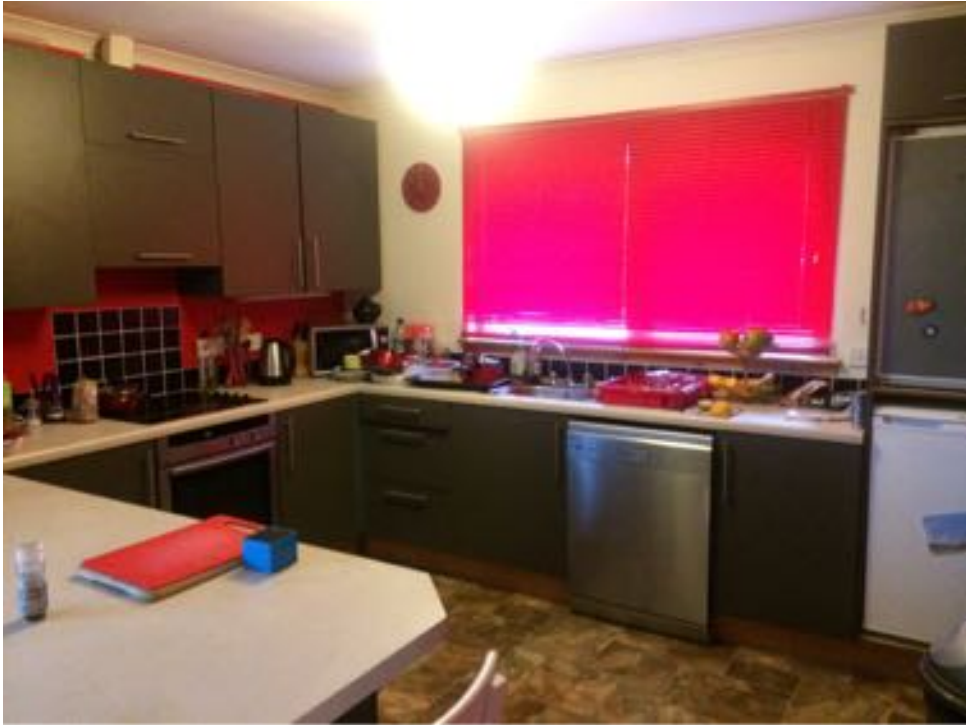
Kitchen

ELEMENT	DESCRIPTION	CONDITION	RECOMMENDED REPAIRS	PRIORITY	COST
Galleries and balconies	-				
<b>STAIRS</b>	-				
<b>ROOMS</b> Partitions, finishes, cornices, doors, ironmongery etc KITCHEN/ DINING	Plasterboard lining, covered ceiling, timber skirtings and flush timber doors etc	Reasonable condition			
STUDY	Plasterboard lining	Reasonable condition			
UTILITY	Plasterboard lining, oil fire boiler located in utility	Reasonable condition			
LIVING	Plasterboard lining	Reasonable condition			
CORRIDOR	Plasterboard lining	Minor marks to paint work on walls	Touch up	D	50
BEDROOM 1	Plasterboard lining	Reasonable condition			
BATHROOM	Plasterboard lining	Minor crack behind bath	Re-seal	D	50
BEDROOM 2	Plasterboard lining	Reasonable condition			
BEDROOM 3	Plasterboard lining	Reasonable condition			
BEDROOM 4	Plasterboard lining	Reasonable condition			
BEDROOM 5 and EN-SUITE	Plasterboard lining	Reasonable condition, en-suite could benefit from re-painting	Make good decoration to en-suite	D	50
