## Quinquennial Report

### **Breakish Manse**

Church of Scotland Lochcarron and Skye Presbytery  
November 2016

# PROPERTY BREAKISH MANSE

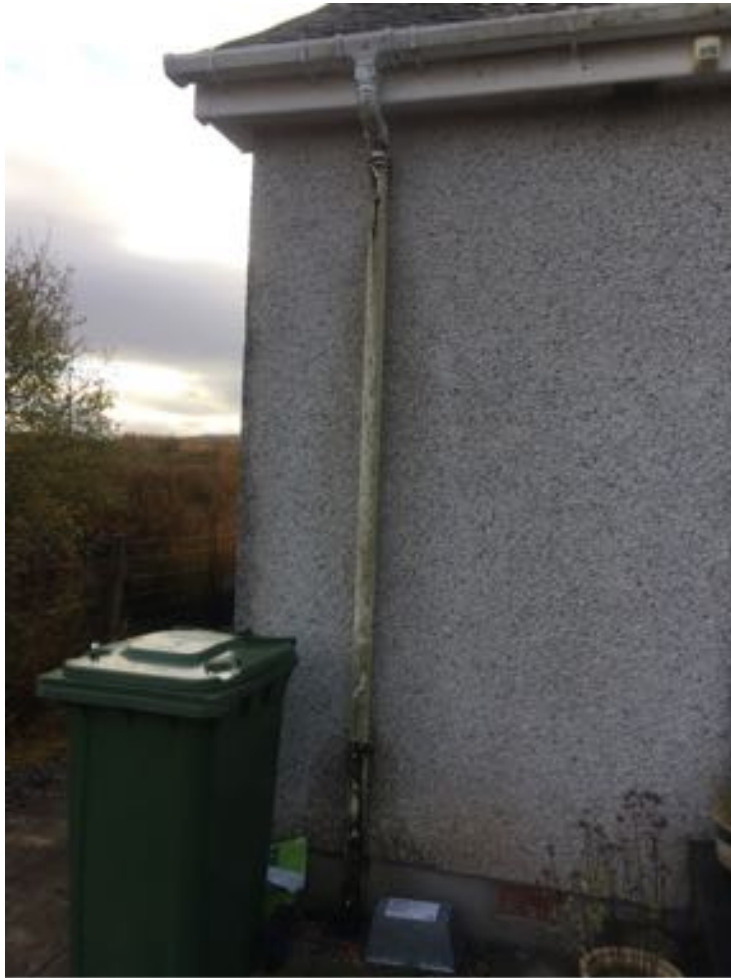
Downpipe at South East corner showing algal growth

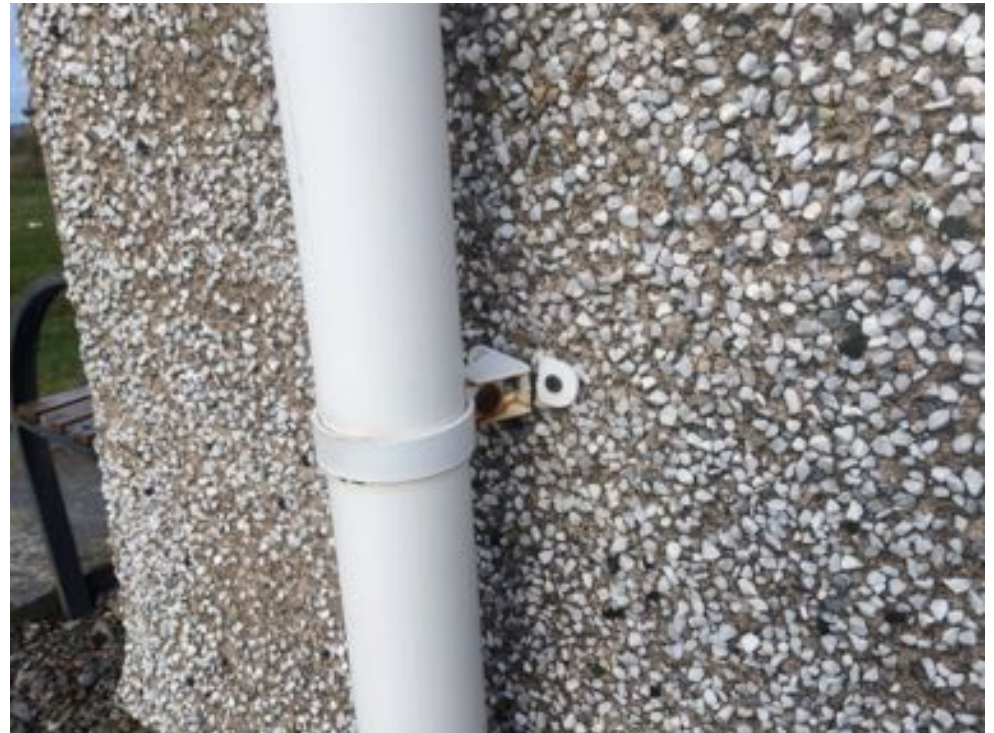
Broken gutter bracket West elevation

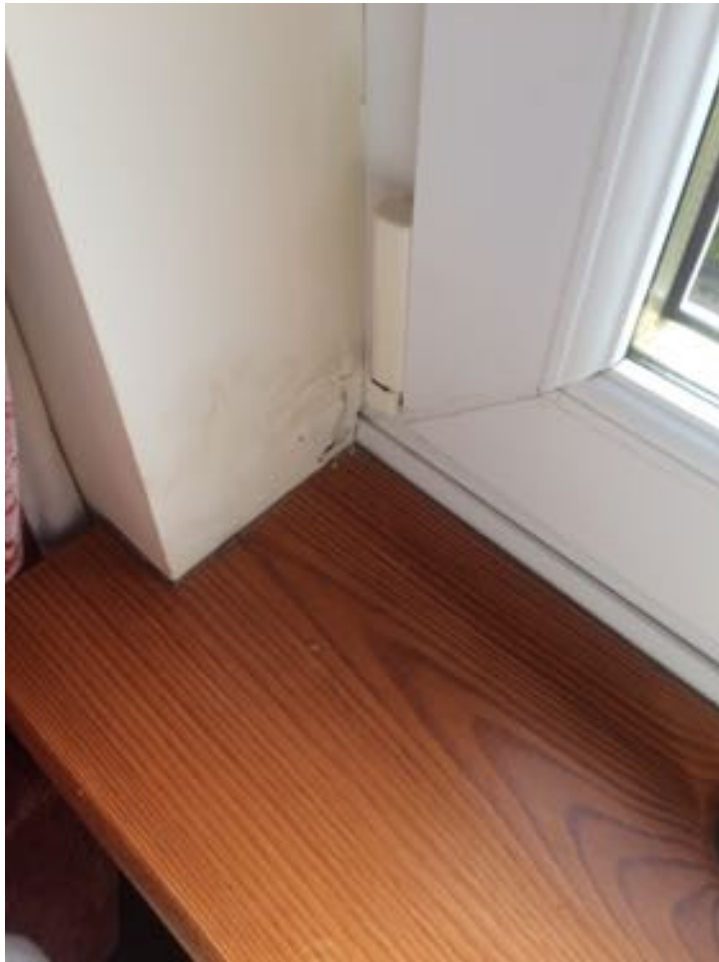
Damp ingress at corner of window in bedroom 3

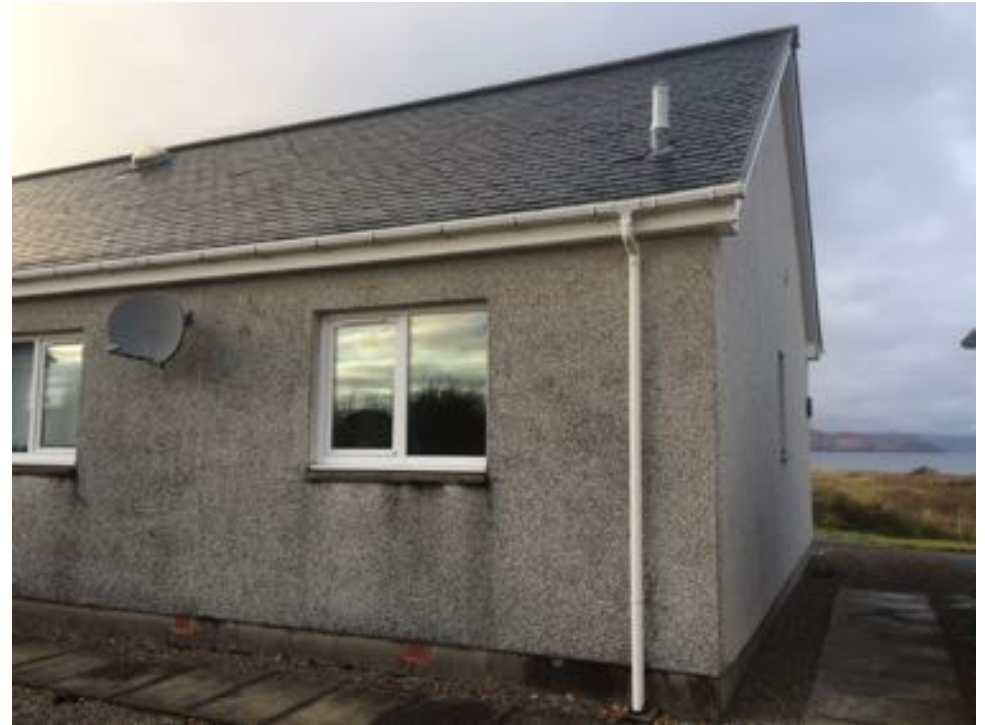
External damp stain at rear window

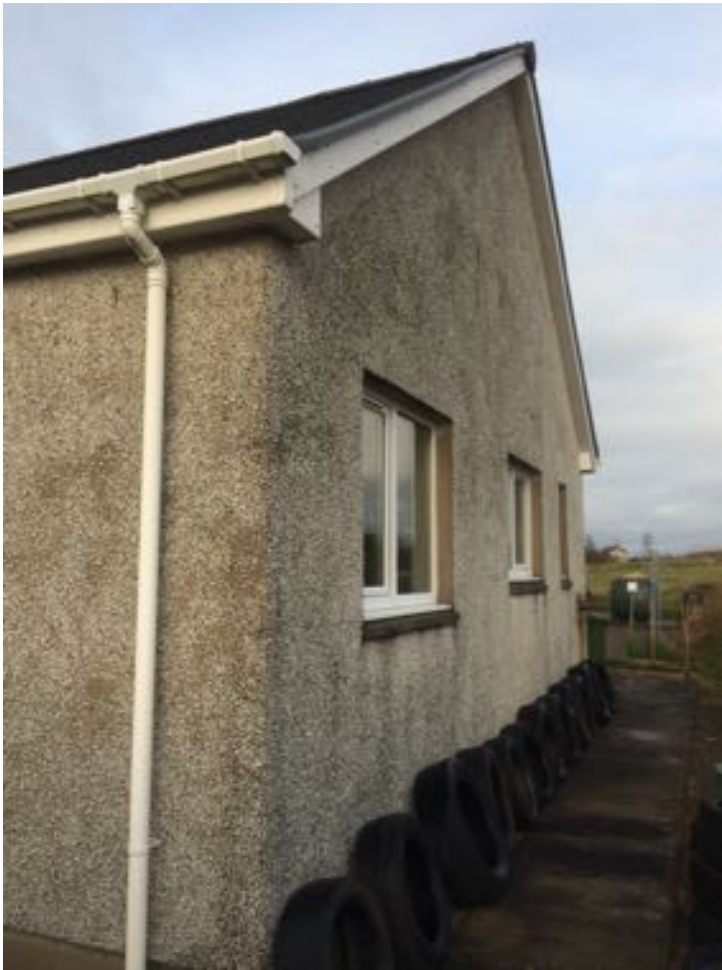
ELEMENT	DESCRIPTION	CONDITION	RECOMMENDED REPAIRS	PRIORITY	COST
Wall finish	Dry dash render finish	Render is rather worn on the west face of the building, also some staining and discolouration			
Metalwork etc	-				
<b>CHIMNEYS AND FLUES</b>	Chimney in middle of west elevation and balanced flue to boiler in utility room	Render on chimney is weathered and may need to be renewed in medium term. Protective cage to flue is rusty	Re-render chimney, replace cage	D	400
<b>EXTERNAL WOODWORK</b>	UPVC fascias and soffits	Reasonable condition			
<b>DOORS AND WINDOWS</b>	UPVC double glazed windows UPVC front and rear doors Sun tube to corridor	Mastic seal around some of the windows has become detached, especially at rear bedroom on the south side.	Re-seal		
<b>EXTERNAL PAINTING</b>	None				
<b>EXTERNAL DRAINAGE</b>	Surface water to soakaway Foul drainage to septic tank	Appears satisfactory			
<b>GARDEN AND GROUNDS</b>	Tarmac drive Gravel parking area Grass garden area Garage adjacent to house	Satisfactory  Garage construction in blockwork and dry dash render, slate roof and UPVC fascias.

Rear elevation South East gable showing worn dry dash render
